ANNUAL REPORT FOR 2014

Bald Creek Site #8 Mitigation Site
Yancey County
TIP No. R-2518B
COE Action ID: SAW-2007-2197-357/300
DWR #: 20071134

Prepared By:
Natural Environment Section & Roadside Environmental Unit
North Carolina Department of Transportation
December 2014

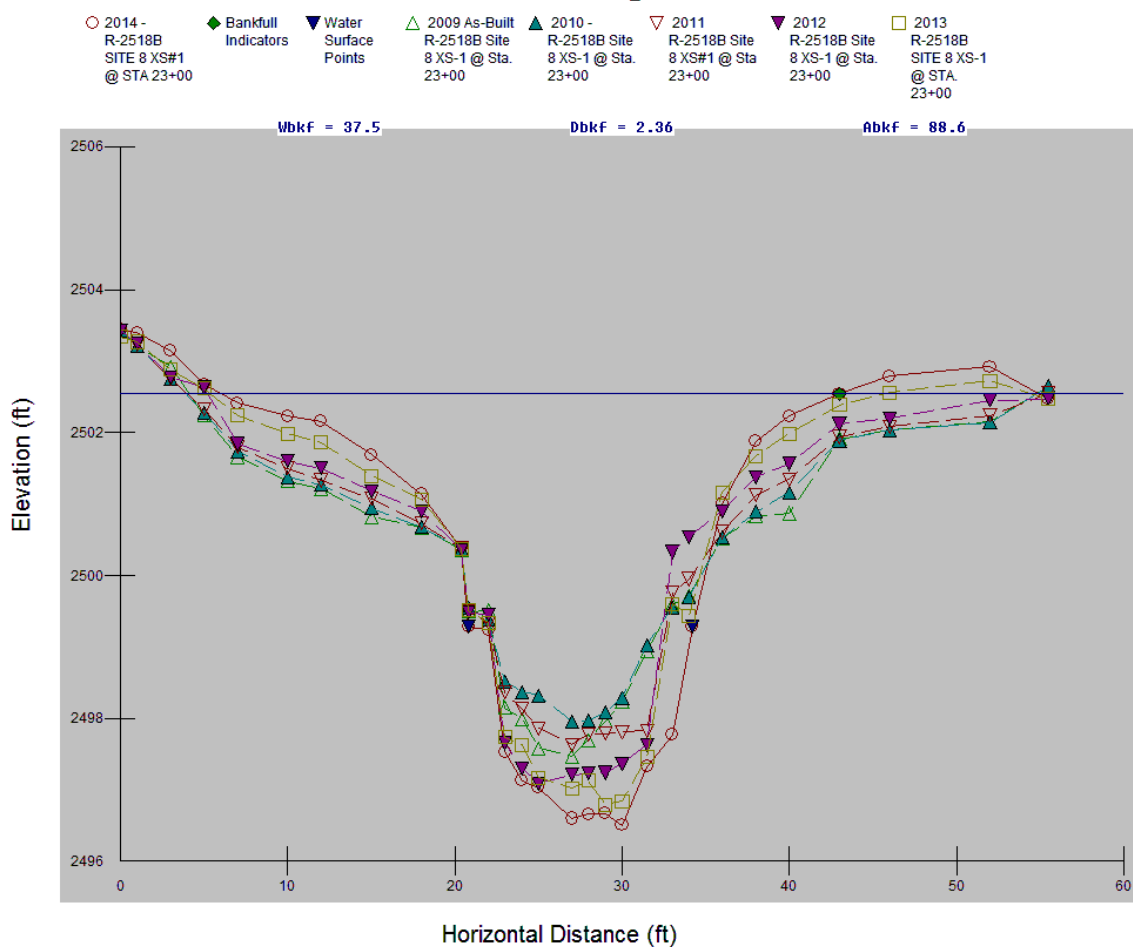
R-2518B SITE 8 XS#1 @ STA 23+00

Site #8: Cross-Section #1 (Pool) Abbreviated Morphological Summary*					
	2010	2011	2012	2013	2014
Bankfull Cross Sectional Area (ft ²)	63.37	66.88	73.56	81.04	88.63
Maximum Bankfull Depth (ft.)	3.93	4.31	5.03	5.6	6.03
Bankfull Mean Depth (ft.)	1.73	1.83	2	2.2	2.36
Bankfull Width (ft.)	36.56	36.53	36.71	36.79	37.54

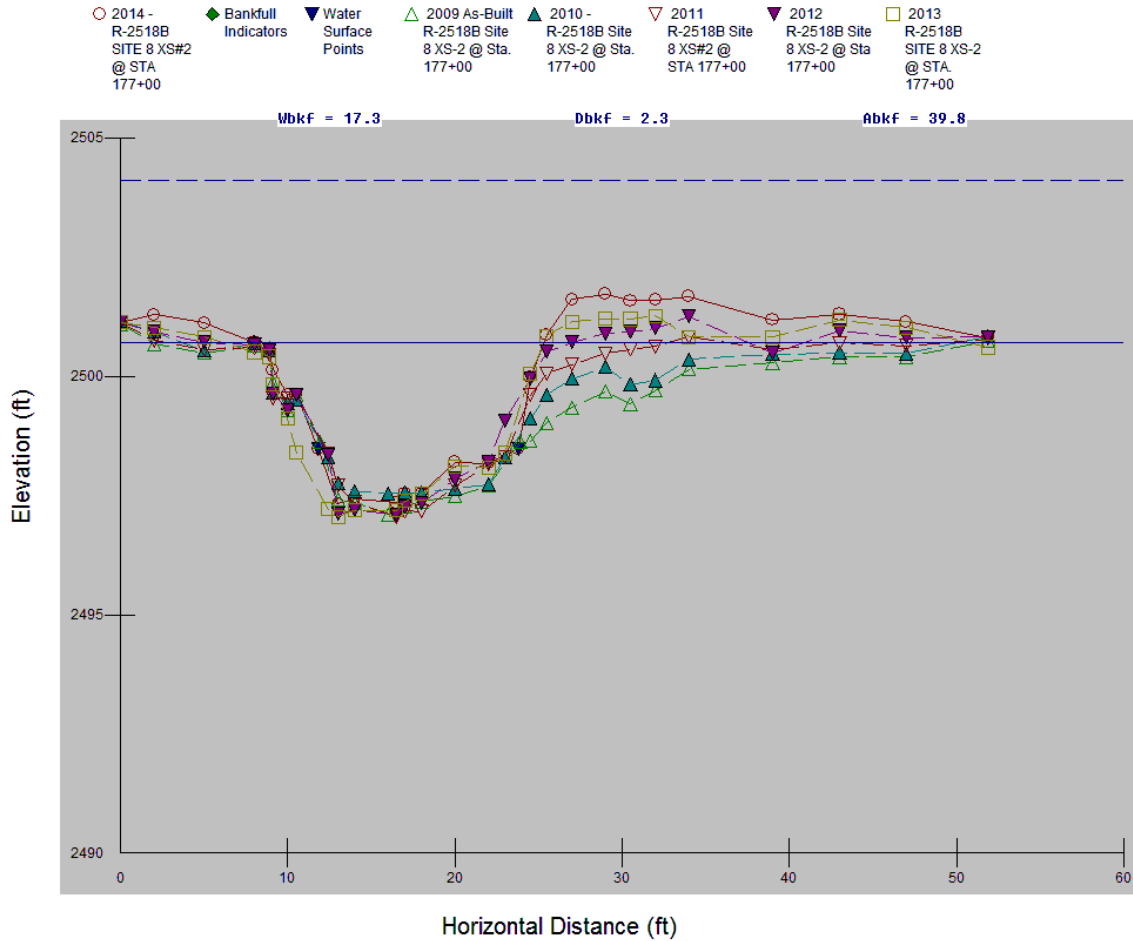
R-2518B SITE 8 XS#2 @ STA 177+00

Site #8: Cross-Section #2 (Rifle) Abbreviated Morphological Summary					
	2010	2011	2012	2013	2014
Bankfull Cross Sectional Area (ft. ²)	39.07	41.53	40.05	39.95	39.77
Maximum Bankfull Depth (ft.)	2.81	3.54	3.57	3.45	3.39
Width of the Floodprone Area (ft.)	51.9	51.9	51.9	51.9	51.9
Bankfull Mean Depth (ft.)	1.56	1.79	1.89	2.34	2.3
Width/Depth Ratio	16.06	12.99	11.2	7.3	7.53
Entrenchment Ratio	2.07	2.23	2.45	3.04	3
Bankfull Width (ft.)	25.06	23.25	21.16	17.08	17.32

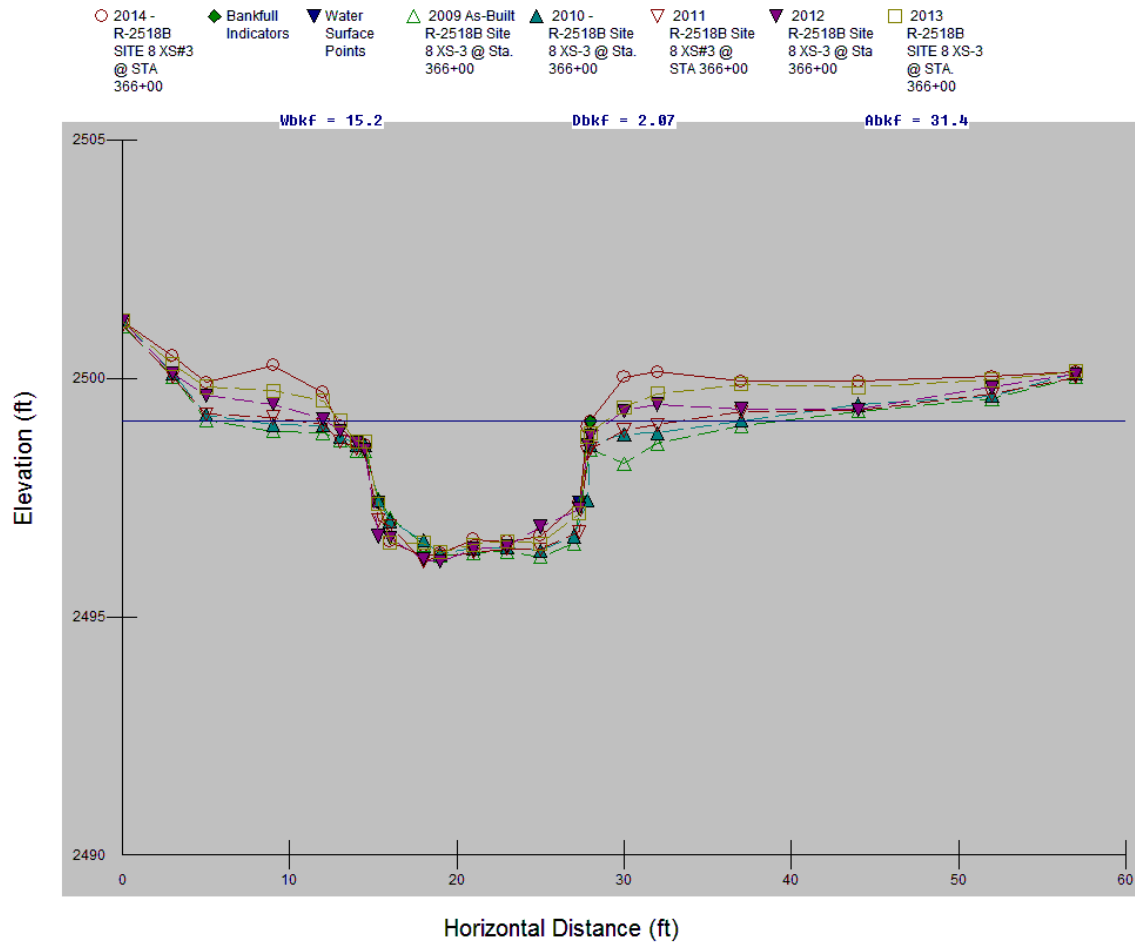
R-2518B SITE 8 XS#3 @ STA 366+00

Site #8: Cross-Section #3 (Pool) Abbreviated Morphological Summary*					
	2010	2011	2012	2013	2014
Bankfull Cross Sectional Area (ft ²)	25.73	25.79	28.22	28.17	31.43
Maximum Bankfull Depth (ft.)	2.28	2.36	2.64	2.5	2.82
Bankfull Mean Depth (ft.)	1.91	1.86	1.93	1.96	2.07
Bankfull Width (ft.)	13.5	13.9	14.58	14.4	15.15

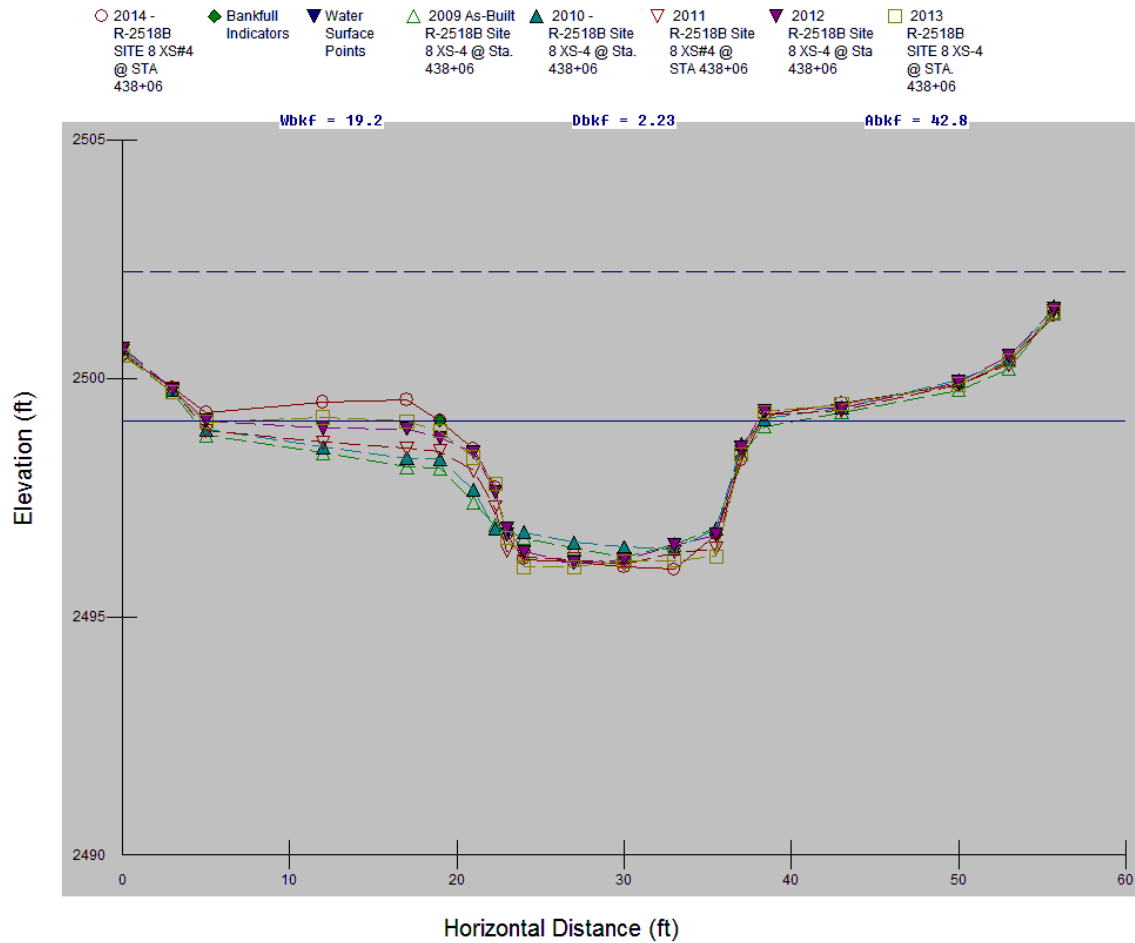
R-2518B SITE 8 XS#4 @ STA 438+06

Site #8: Cross-Section #4 (Riffle) Abbreviated Morphological Summary					
	2010	2011	2012	2013	2014
Bankfull Cross Sectional Area (ft ²)	25.58	31.87	33.97	39.54	42.81
Maximum Bankfull Depth (ft.)	1.88	2.36	2.62	2.85	3.12
Width of the Floodprone Area (ft.)	50.11	54.31	55.48	55.7	55.7
Bankfull Mean Depth (ft.)	1.44	1.77	1.85	2.11	2.23
Width/Depth Ratio	12.32	10.19	9.94	8.89	8.63
Entrenchment Ratio	2.83	3.01	3.02	2.97	2.9
Bankfull Width (ft.)	17.74	18.04	18.38	18.76	19.24

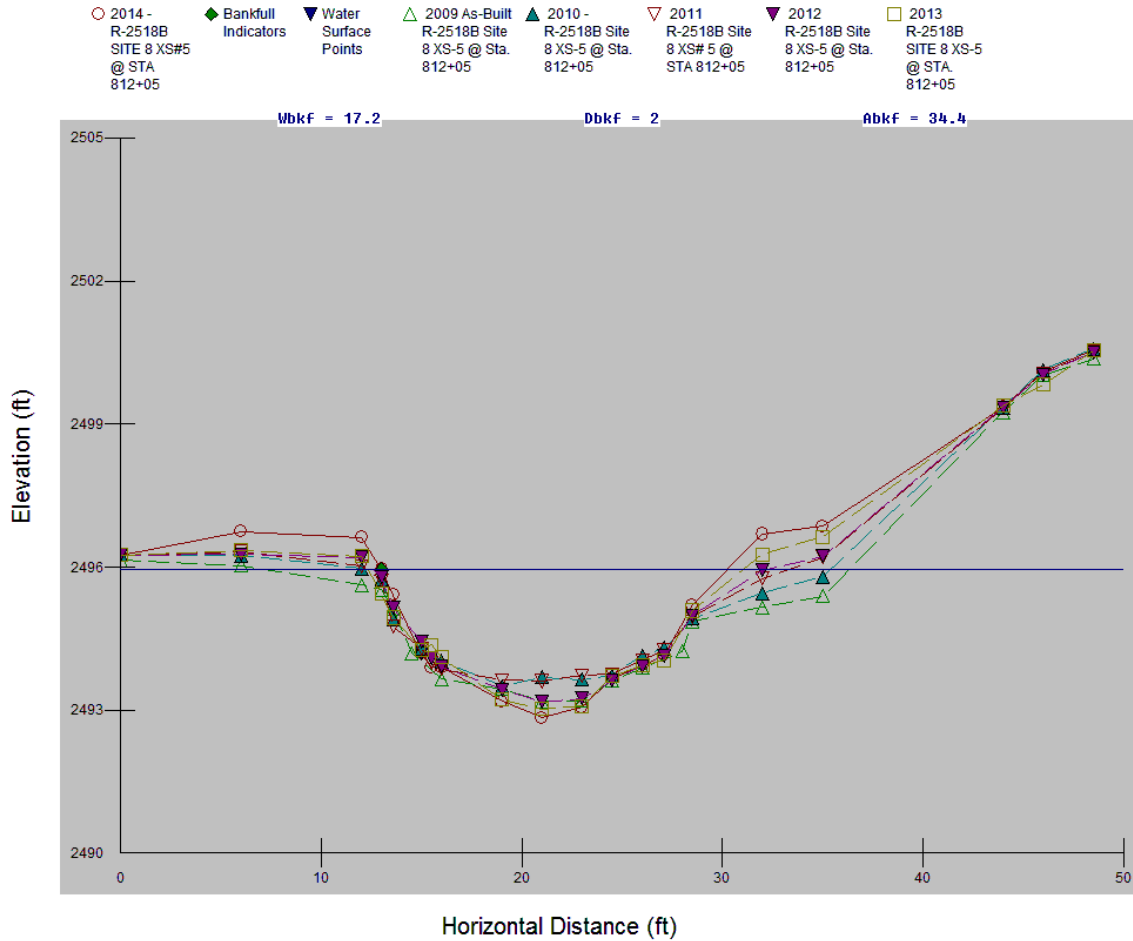
R-2518B SITE 8 XS#5 @ STA 812+05

Site #8: Cross-Section #5 (Pool) Abbreviated Morphological Summary*					
	2010	2011	2012	2013	2014
Bankfull Cross Sectional Area (ft²)	29.34	28.13	31.18	25.67	34.43
Maximum Bankfull Depth (ft.)	2.25	2.11	2.62	2.41	3.11
Bankfull Mean Depth (ft.)	1.36	1.49	1.69	1.55	2
Bankfull Width (ft.)	21.57	18.82	18.48	16.54	17.25

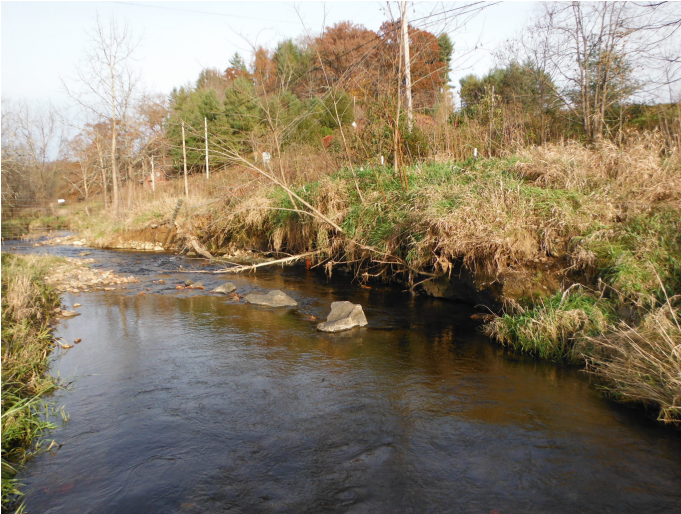
and photo documentation at the permanent photo point locations would be completed. All other monitoring activities will continue to be completed throughout the five year monitoring period. The channel is stable throughout, except for, the right bank just downstream of Cross Section #5 which is eroding. NCDOT plans to investigate possible solutions to stabilize this bank. Pebble counts were not required per the permit conditions and therefore were not completed. Multiple bankfull events were documented by a surface water gauge at Site 8 during the 2014 monitoring year.

The Bald Creek Site #8 Mitigation Site has met the required monitoring protocols for the fifth formal year of monitoring on the stream and the third formal year of monitoring on the planted vegetation. The channel is stable throughout, except for, the right bank just downstream of Cross Section #5 which is eroding. NCDOT plans to investigate possible solutions to stabilize this bank. The planted vegetation is surviving at this time. NCDOT proposes to continue stream and vegetation monitoring at the Bald Creek Site #8 Mitigation Site in 2015.

Right bank eroding downstream of Cross Section #5
November 2014
